**WALNUT HOLLOW LAKE DAM  
IRON COUNTY, MISSOURI  
MO 30619**

**PHASE 1 INSPECTION REPORT  
NATIONAL DAM SAFETY INSPECTION**

**WALNUT HOLLOW LAKE DAM**

**Phase I Inspection Report  
National Dam Safety Program**

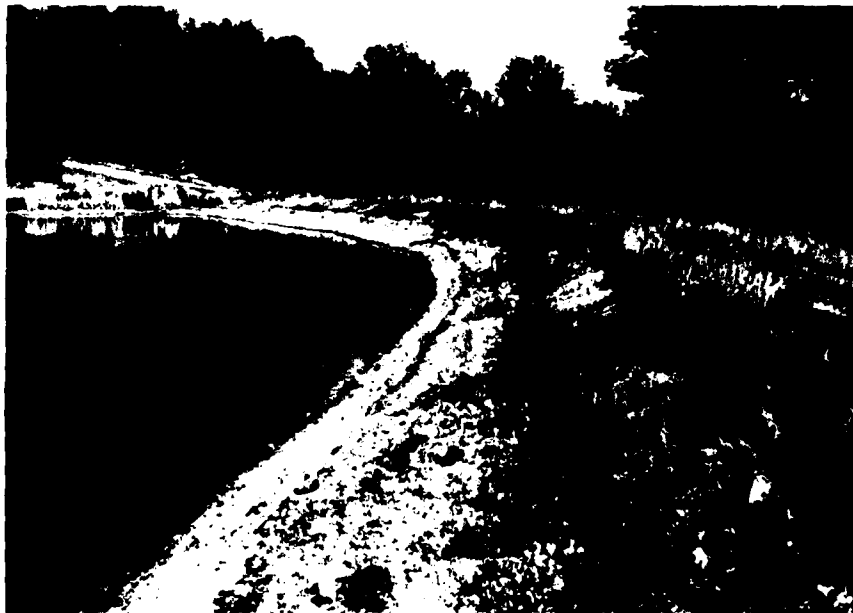
- a. **General.** A field inspection was made of the Walnut Hollow Lake Dam on 11 November, 1980. Mr Ed Glick, caretaker for the property, accompanied the inspection team throughout the inspection. The inspection indicated the dam embankment is in generally good condition; however, the spillways are substantially inadequate for the potential flood conditions at the site.
- b. **Dam.** The dam is constructed of a gravelly, silty clay soil, with some angular gravel (quartz druse). The soil is a tan to red-brown, moderately plastic residual clay (CL). The dam has a moderate to low erosion potential due to its good cohesion and vegetative cover. The upstream face has had the fine soil particles washed out by wave action, leaving the gravel-sized portion (Photo 2).

The dam crest did not exhibit any lateral spreading, deformation, or excessive vertical settling (Photo 2 and Overview). No evidence of any sinkhole development or animal burrows was observed during the inspection.

2. Upstream face of dam. Note gravel that protects against wave erosion. Looking northeast.

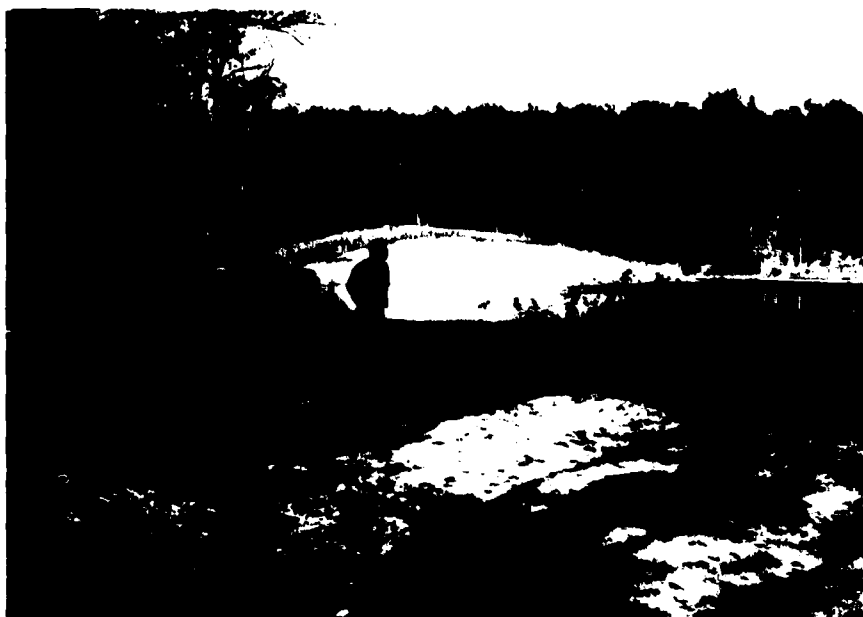
6. Auxiliary spillway at right (southwest) abutment. Note gravel surface and lack of erosion rills or gullies. Note ridge in center of reservoir that was excavated for dam construction. Looking northwest.
